Building sustainably – it starts with the land

□ BY JENNIFER BAUER □

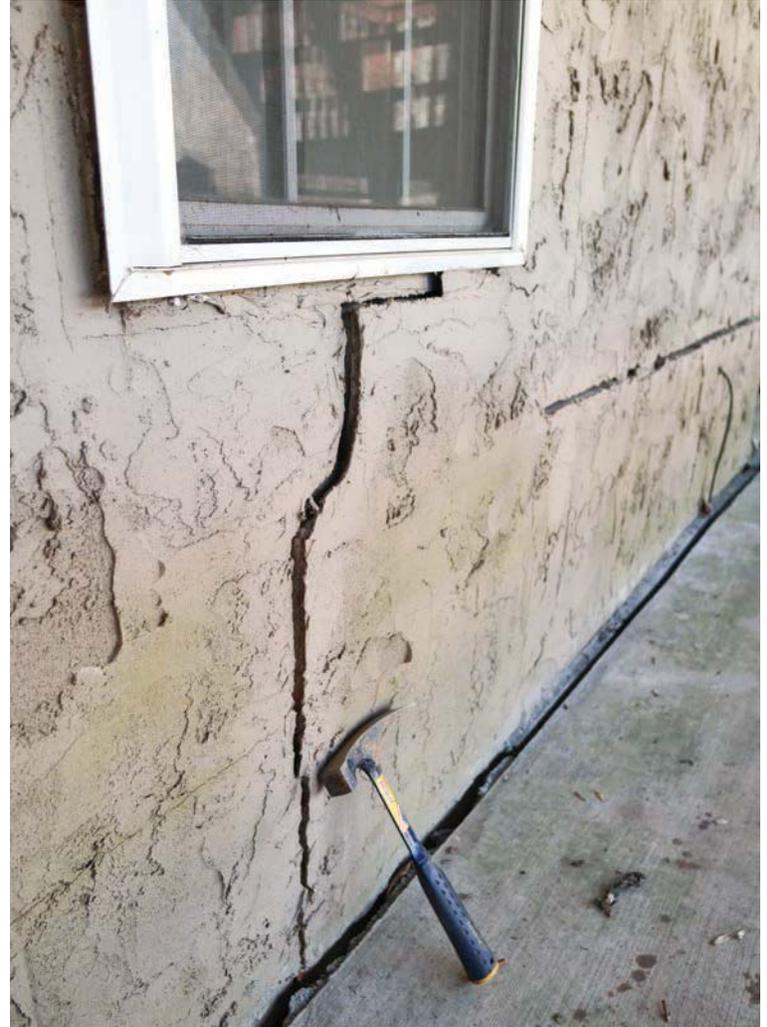
Cracks in the home foundation. Photo by Appalachian Landslide Consultants, PLLC

Then came the rains of 2013, the wettest year on record. Mrs. Green started noticing cracks in their driveway, which then became scarps, as the outer edge of the fill slope started dropping down. After every rain, more and more of the edge would slide down and away, preventing them from using the parking area near their garage. They even started noticing cracks in their basement garage and foundation (see photo, right).

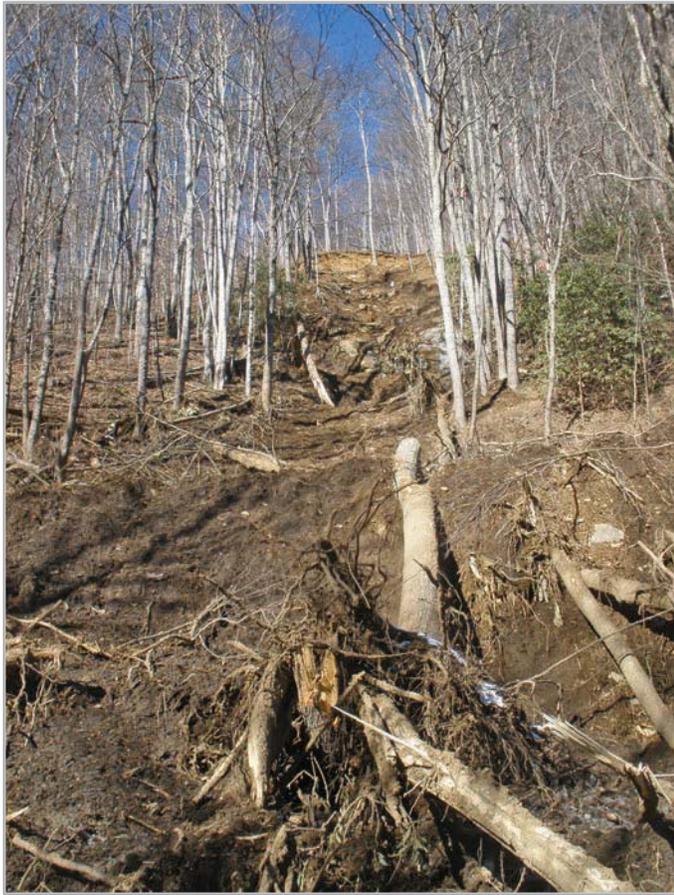
Left: Long Branch natural debris flow, Maggie Valley, Jan. 15-16, 2013. Above: Road embankment failure/debris flow, Maggie Valley, Jan. 15-16, 2013. Photos by Appalachian Landslide Consultants, PLLC

In North Carolina, we know of over 3,500 landslides that have happened since 1916 (from database inventories at Appalachian Landslide Consultants, PLLC (ALC), and the North Carolina Geological Survey (NCGS), as of July 2015). The majority of these (approximately 70 percent) started on natural slopes, or slopes that had not been modified by construction activities (see photo).
